Dilapidation Inspection Report

Type of Report: Dilapidation Inspection

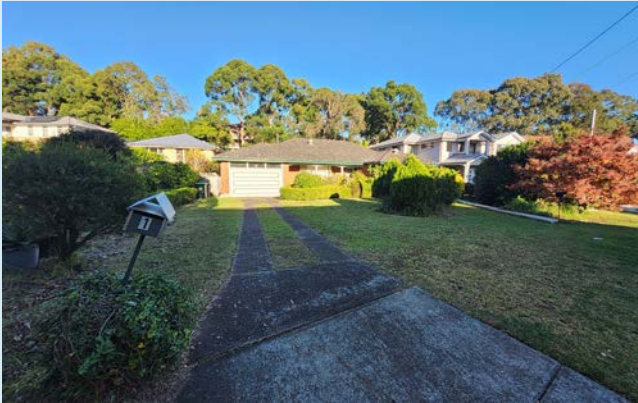
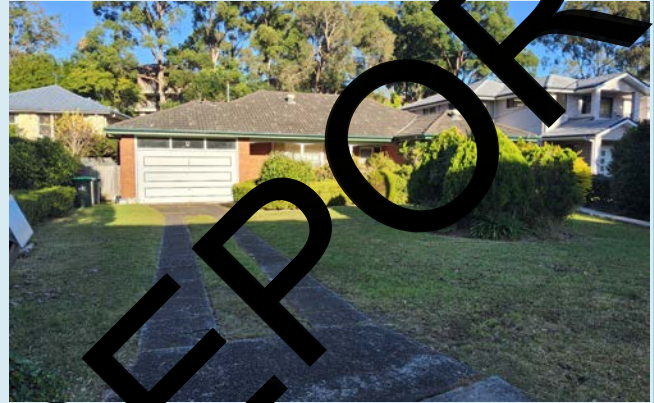
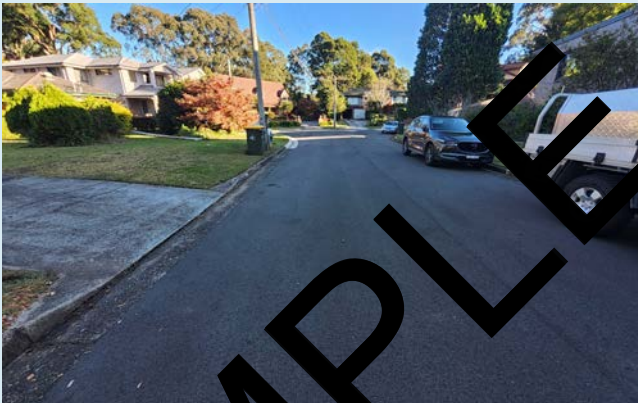
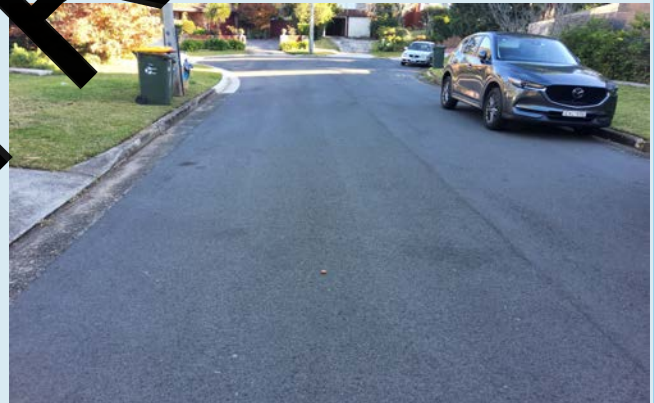
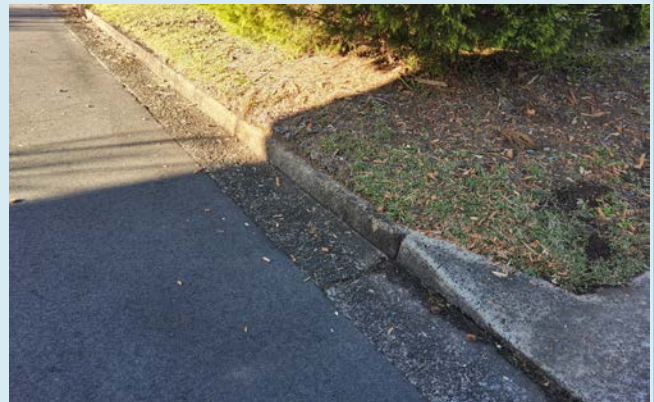
Driveways and paths

Loose paver finish path to the grannyflat.

Cracking to concrete path present.

Moss and discolouration to path present.

Main house driveway, cross over and kerb presenting cracking and damage.

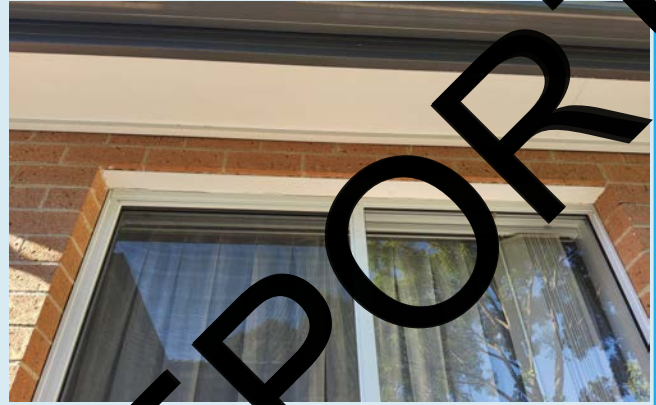
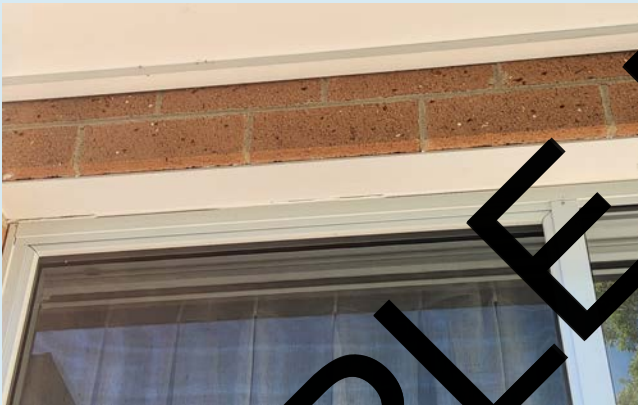
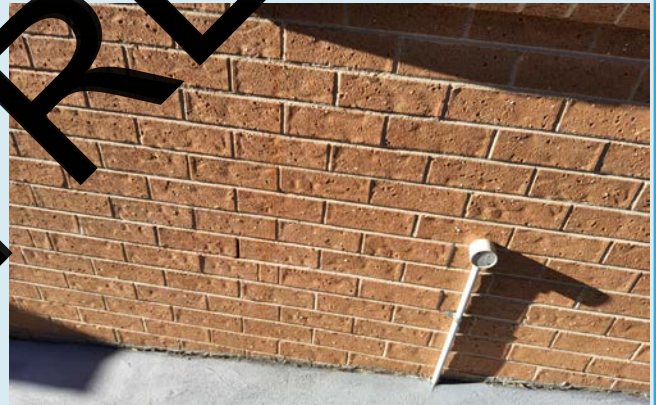
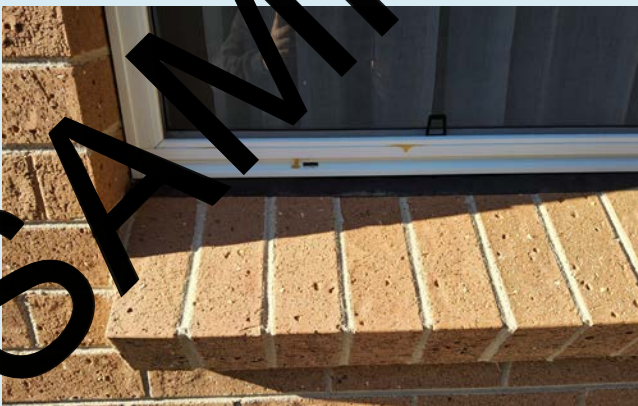
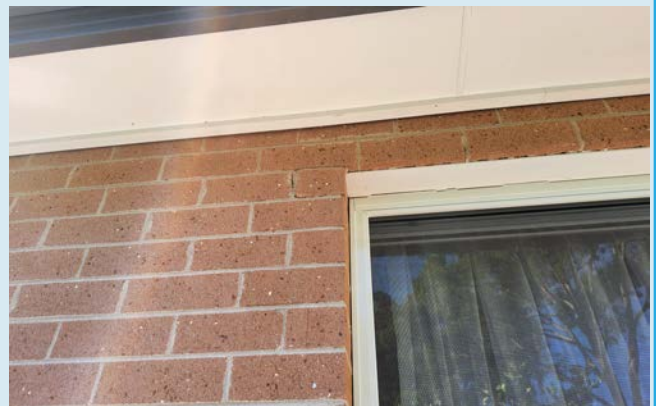
Walls

Mortar missing and mortar cracking to all sides in various areas including entry porch walls and piers.

Windows and door heads sealant cracked throughout the entire granny flat.

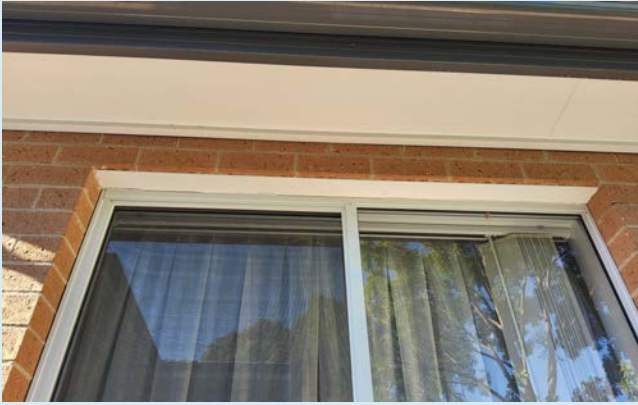
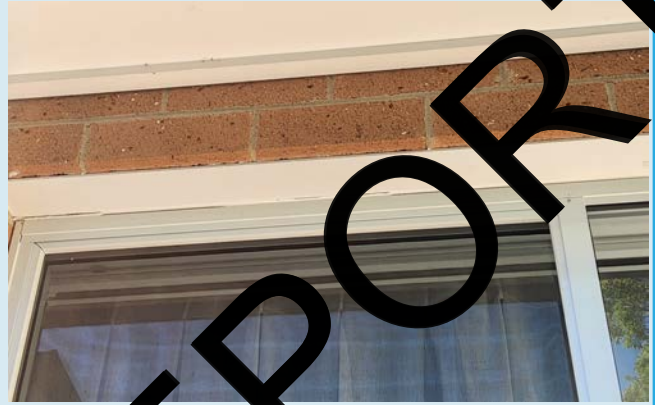
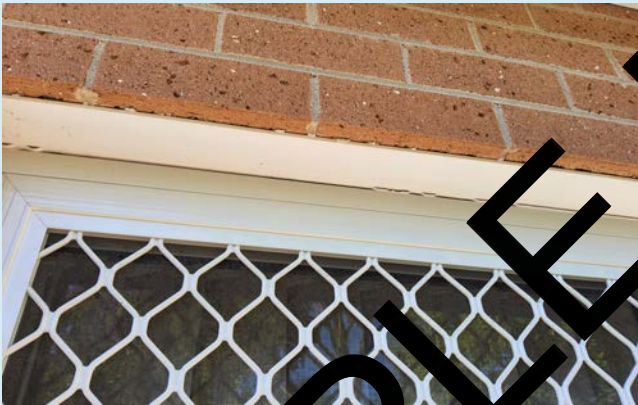
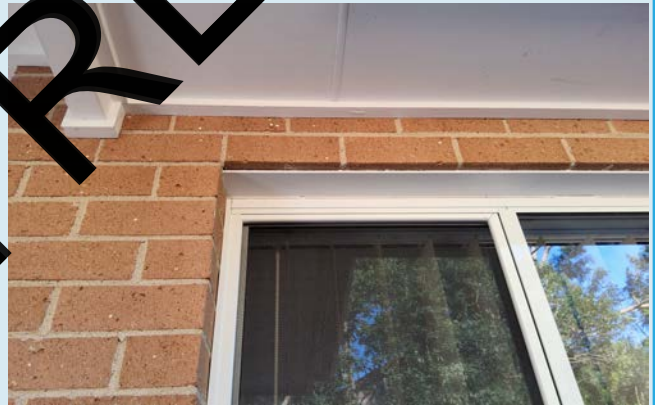
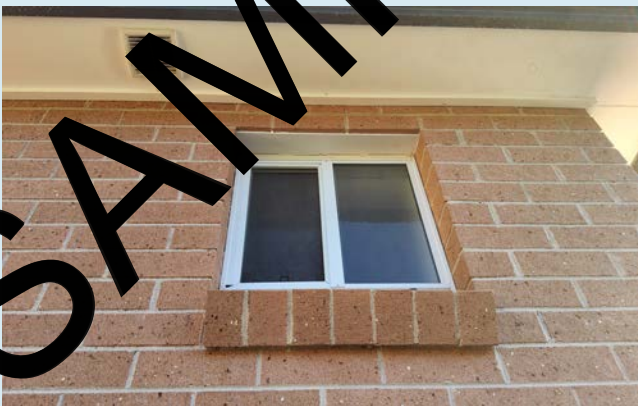
Windows and door heads sealant cracked throughout the entire granny flat.

Gaps to left side of the window at bedroom two.

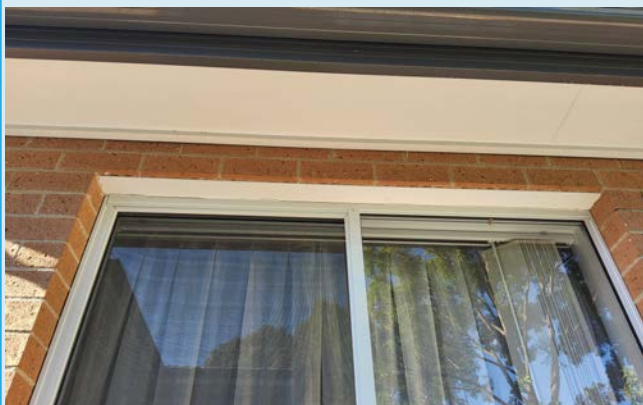
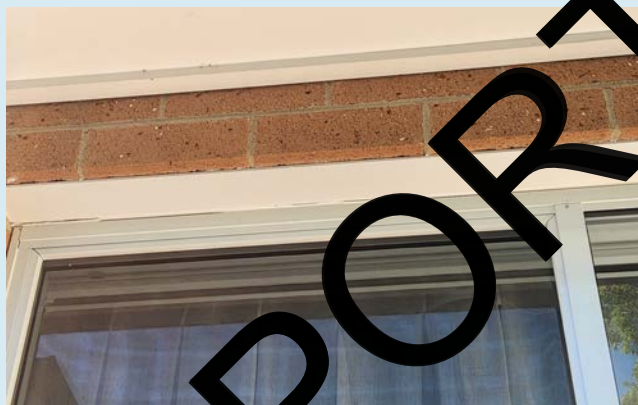
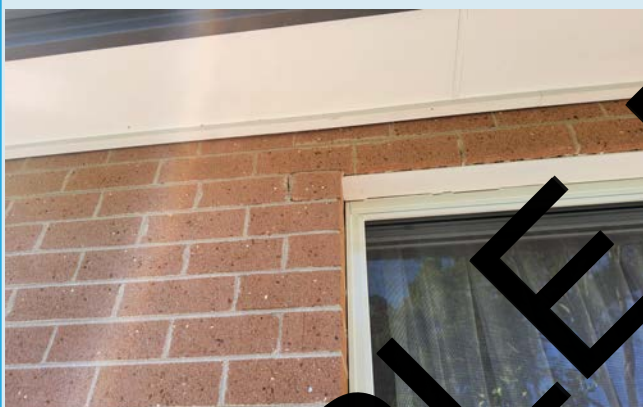
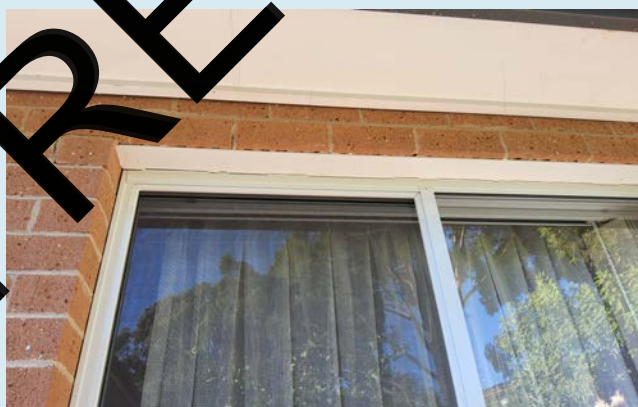
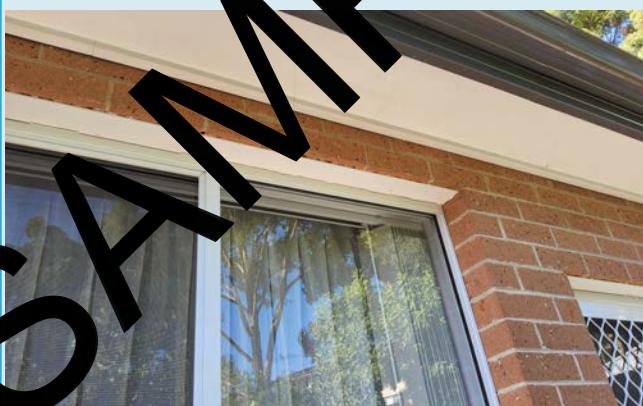
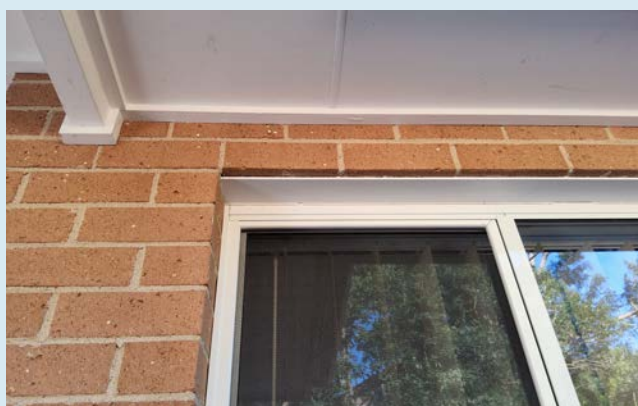
Doors

Windows and door heads sealant cracked throughout the entire granny flat.

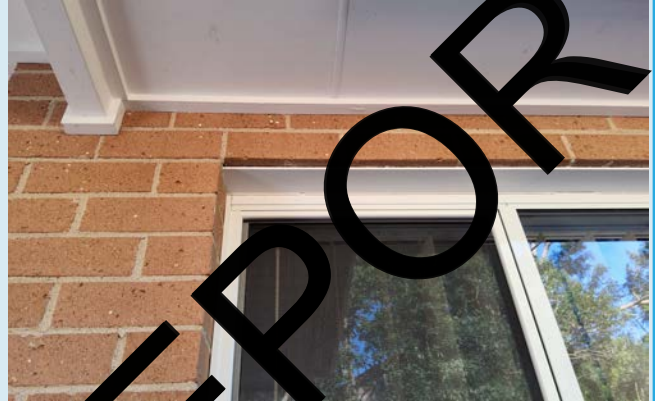
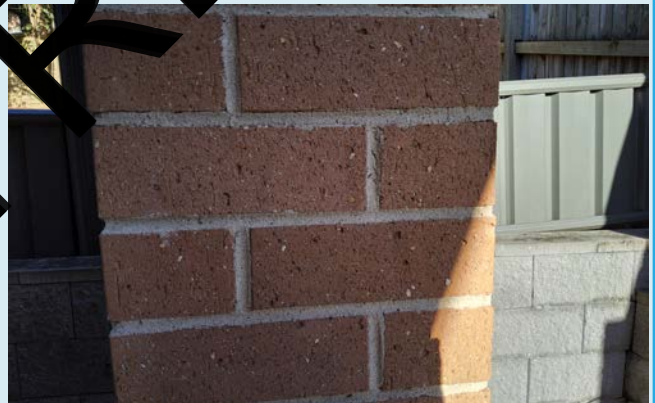
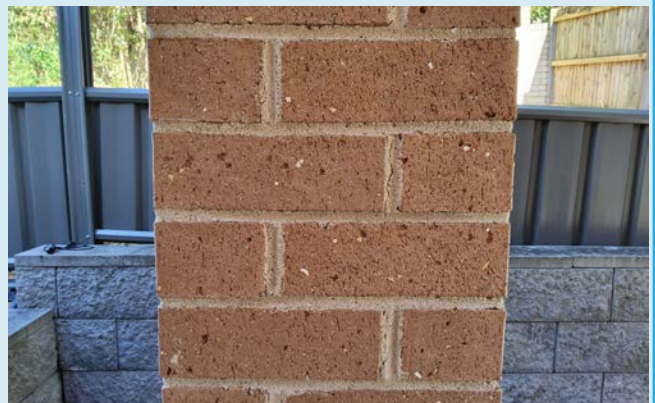
Porch

Mortar missing and mortar cracking to all sides in various areas including entry porch walls and piers.

Cracking to timber trims.

Cracking to sealant above door.

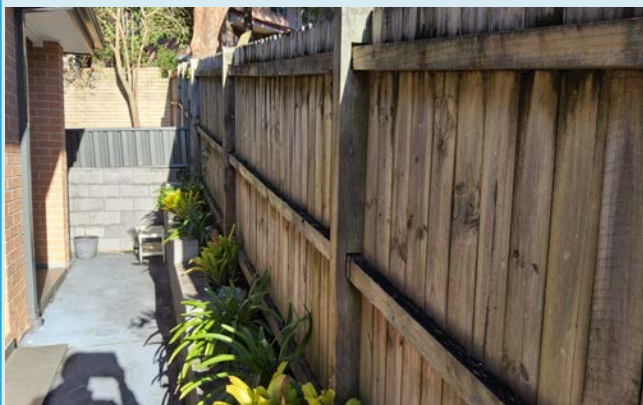
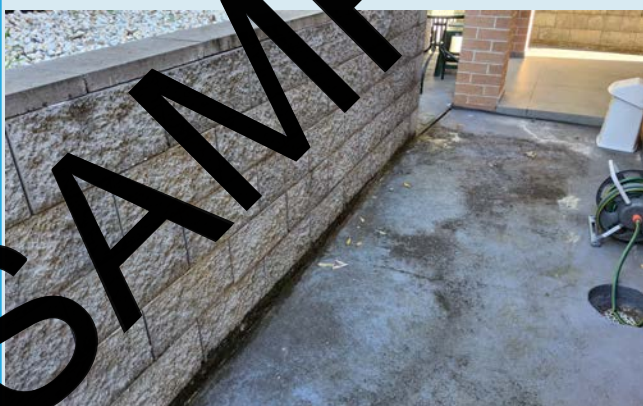
Retaining Walls

Significant Moss and moisture to retaining walls, gaps present to the right hand side.

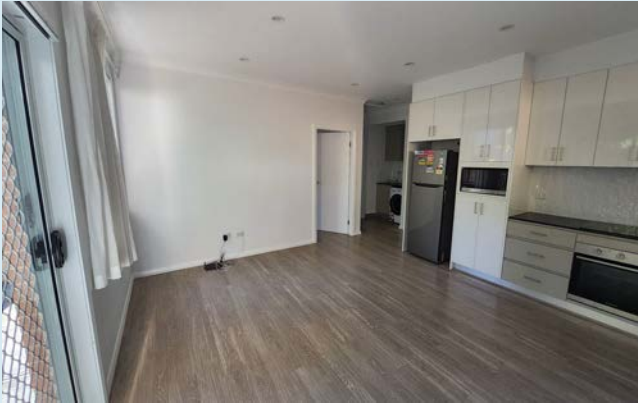
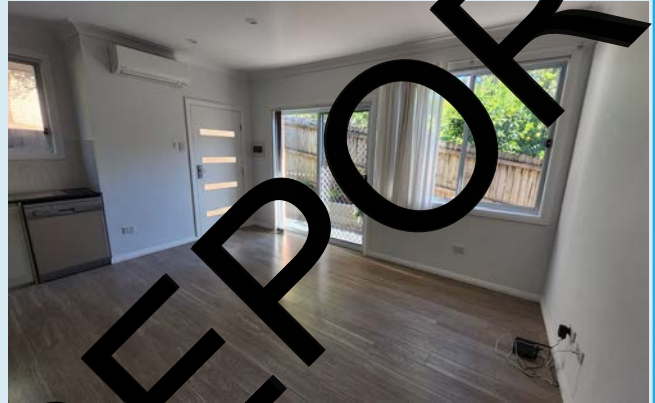
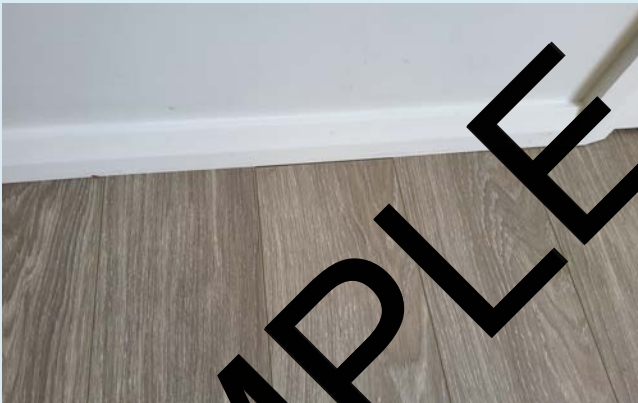
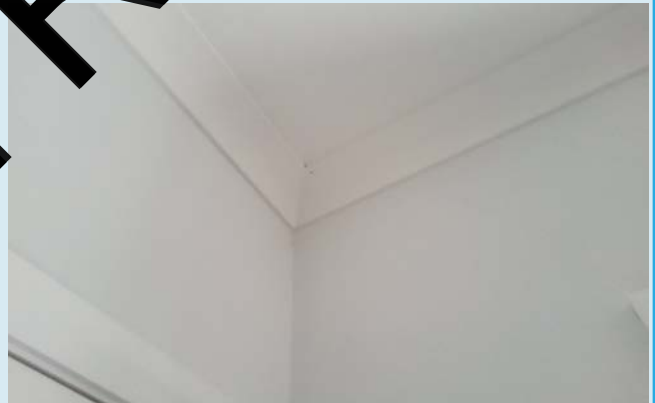
Family Room

This is family room/lounge room and hallway combined due to open plan.

Visible wear and tear present to surfaces.

Cracking to adjoining walls/surfaces, skirting, architraves and to cornice joints.

Storage cupboard right side binding onto the panel.

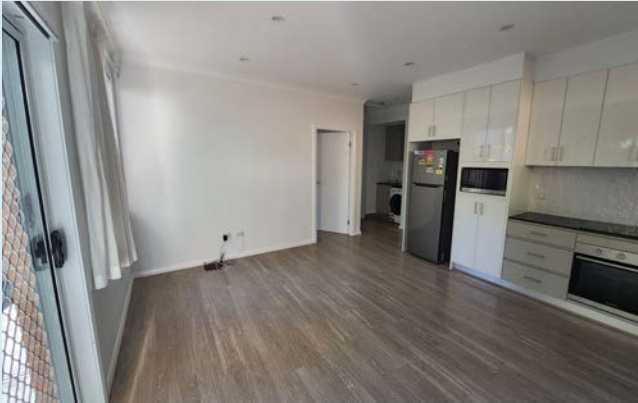
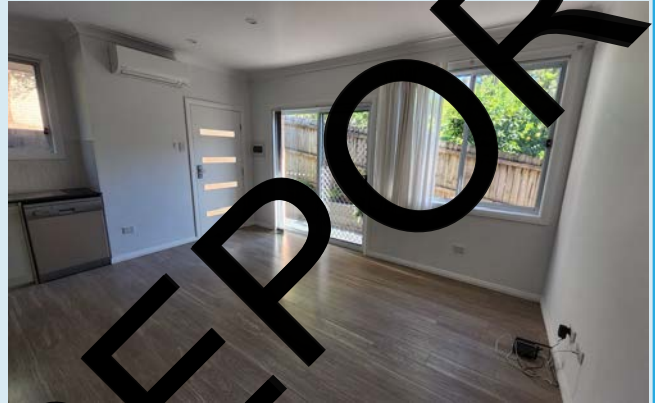
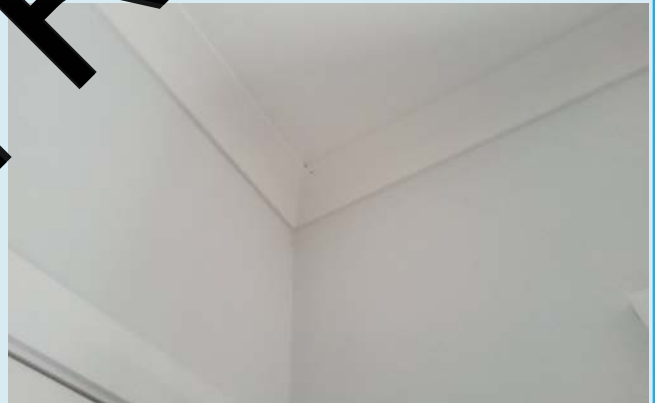
This is family room/lounge room and hallway combined due to open plan.
Visible wear and tear present to surfaces.
Cracking to adjoining walls/surfaces, skirting, architraves and to cornice joints.
Storage cupboard right side binding onto the panel.

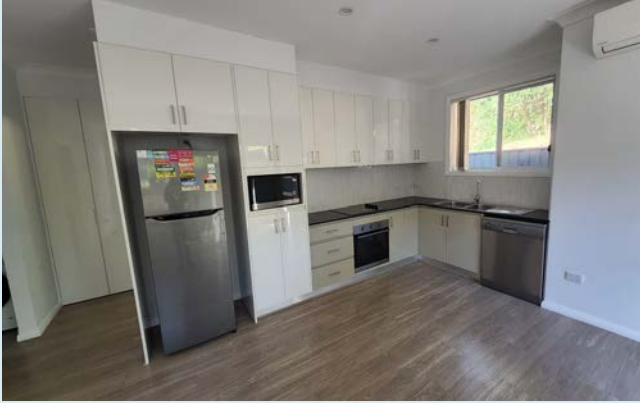
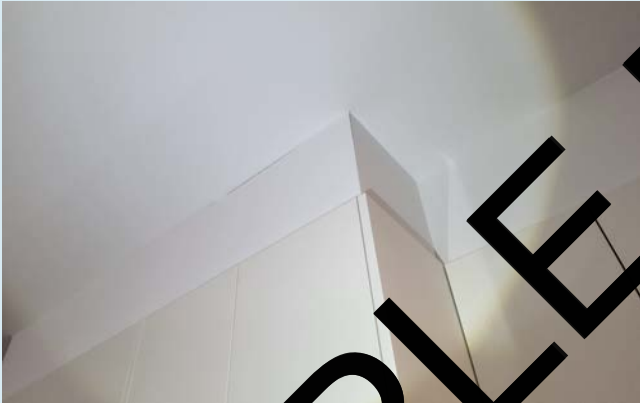
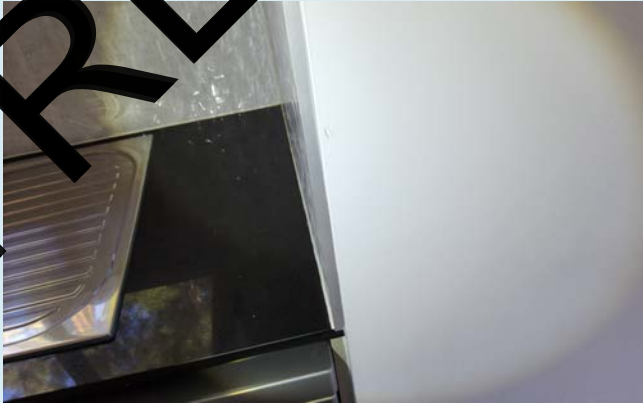
Internal areas	
General Advice On Item	Kitchen
Comments	
<p>Visible wear and tear present to surfaces.</p> <p>Cracking to adjoining walls/surfaces, skirting, architraves and to cornice joints.</p>

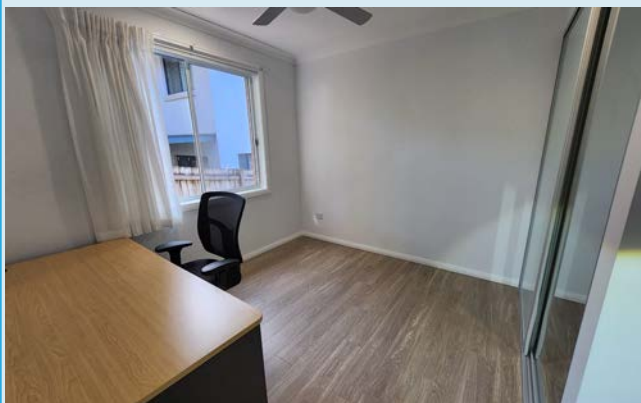
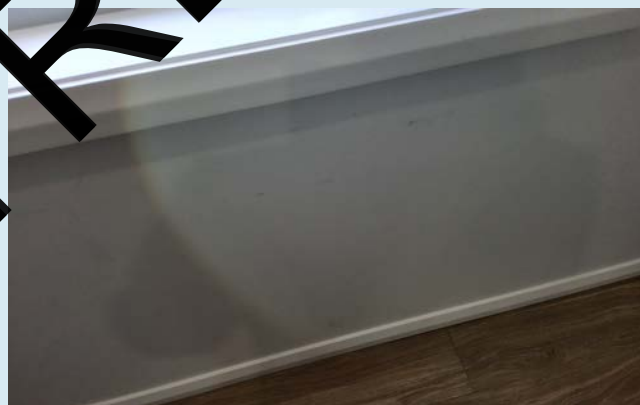
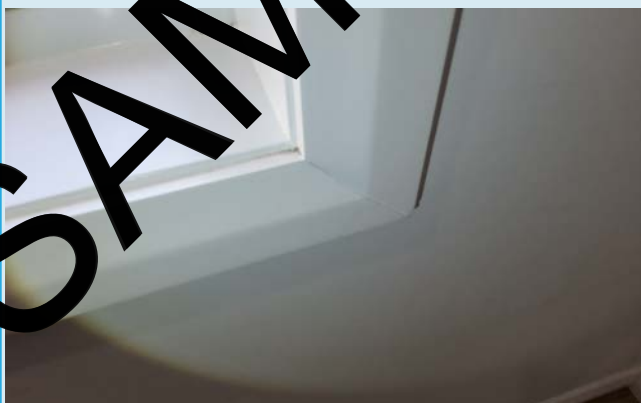
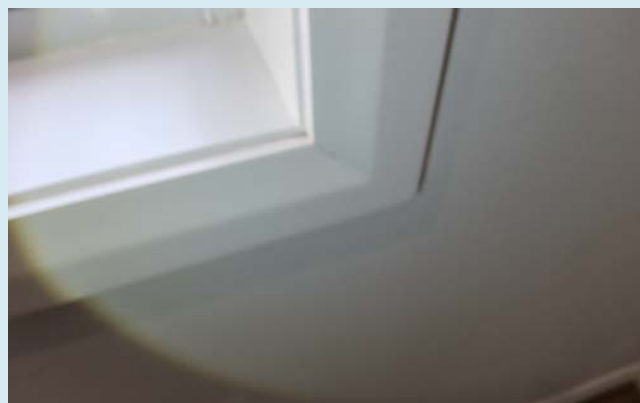
Visible wear and tear present to surfaces.

Cracking to adjoining walls/surfaces, skirting, architraves and to cornice joints.

Robe rubbers damaged.

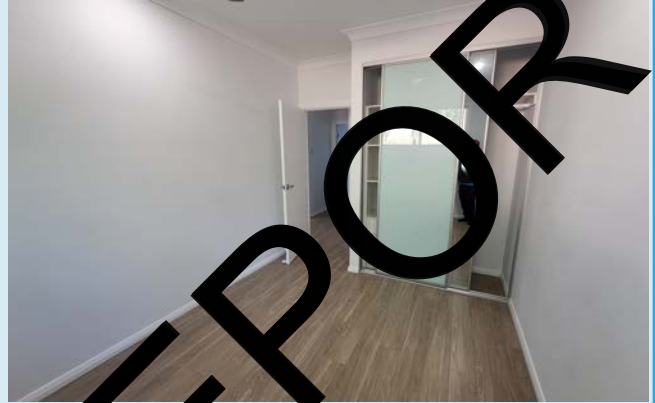
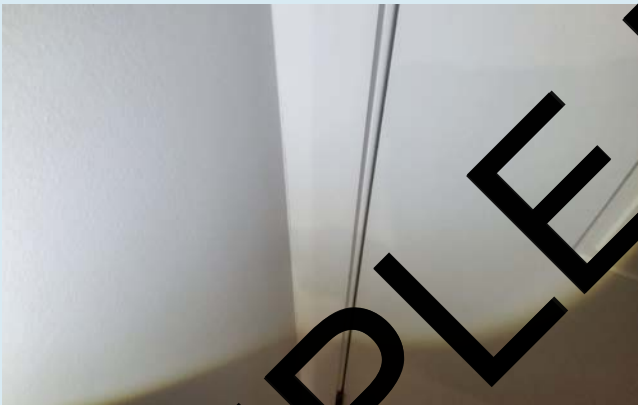
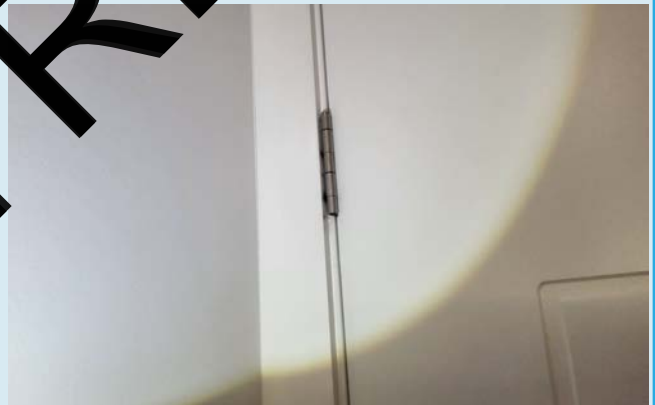
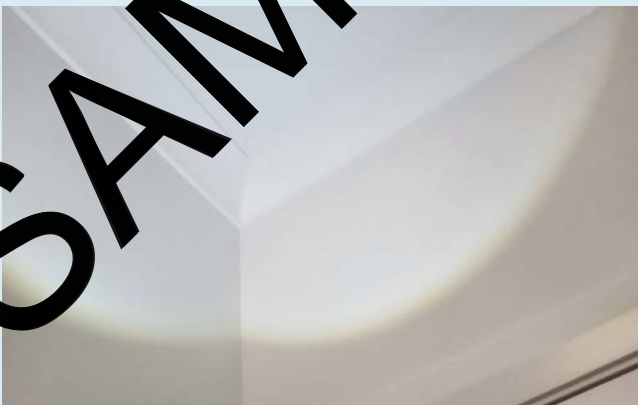
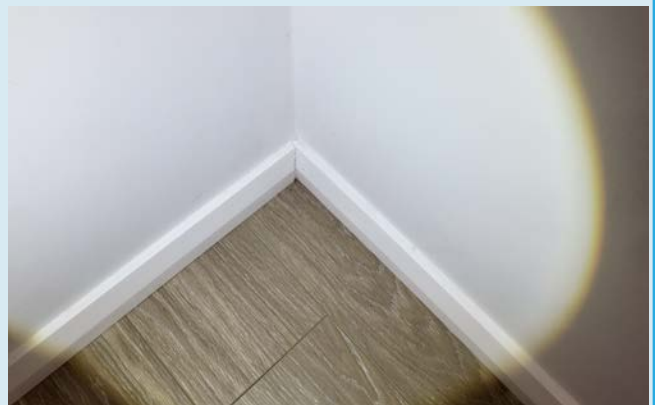
Visible wear and tear present to surfaces.

Cracking to adjoining walls/surfaces, skirting, architraves and to cornice joints.

Draw issue to robe area.

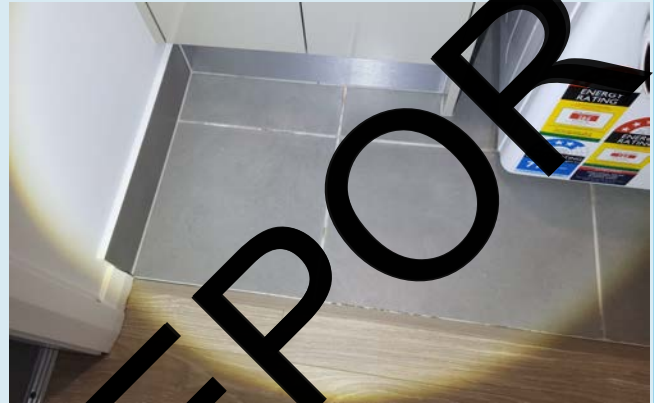
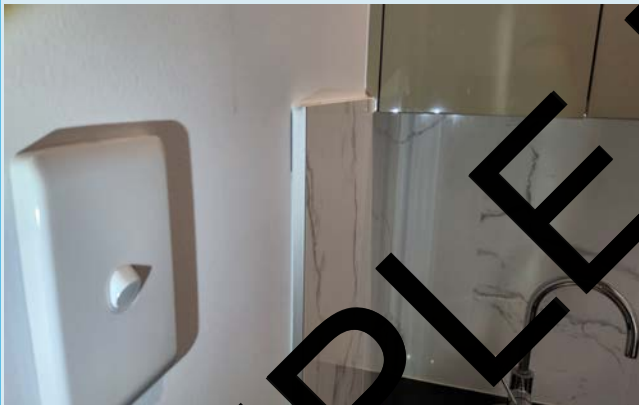
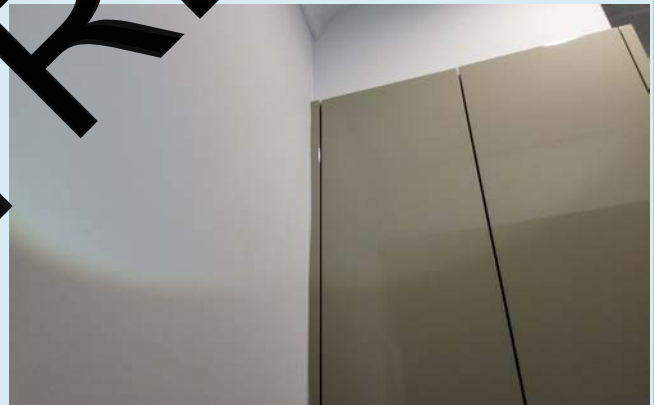
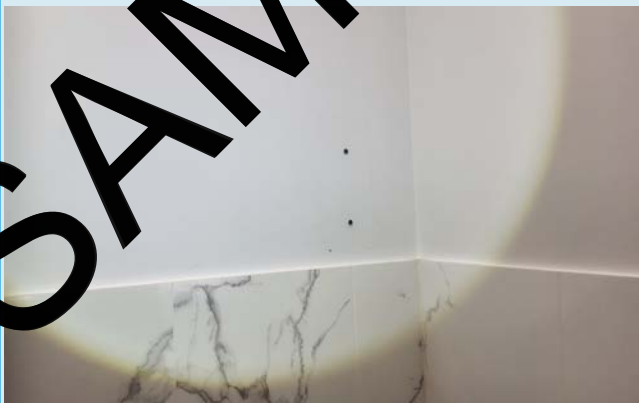
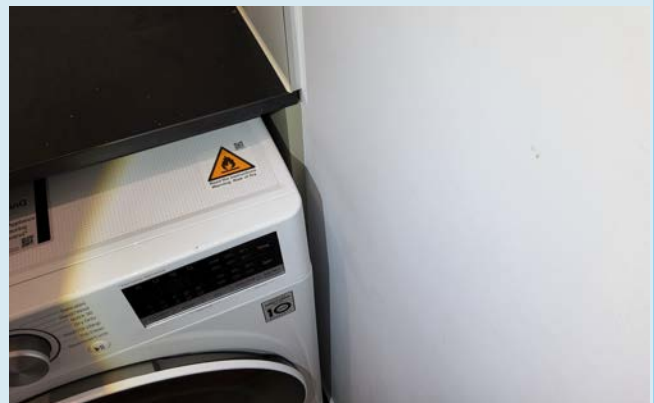
Visible wear and tear present to surfaces.

Cracking to adjoining walls/surfaces, skirting, architraves and to cornice joints.
